**U.S. ARMY CORPS OF ENGINEERS
JURISDICTIONAL DELINEATION**

MONTEREY DYNASTY PROPERTY

SANTA CLARA COUNTY, CALIFORNIA

OCTOBER 2011

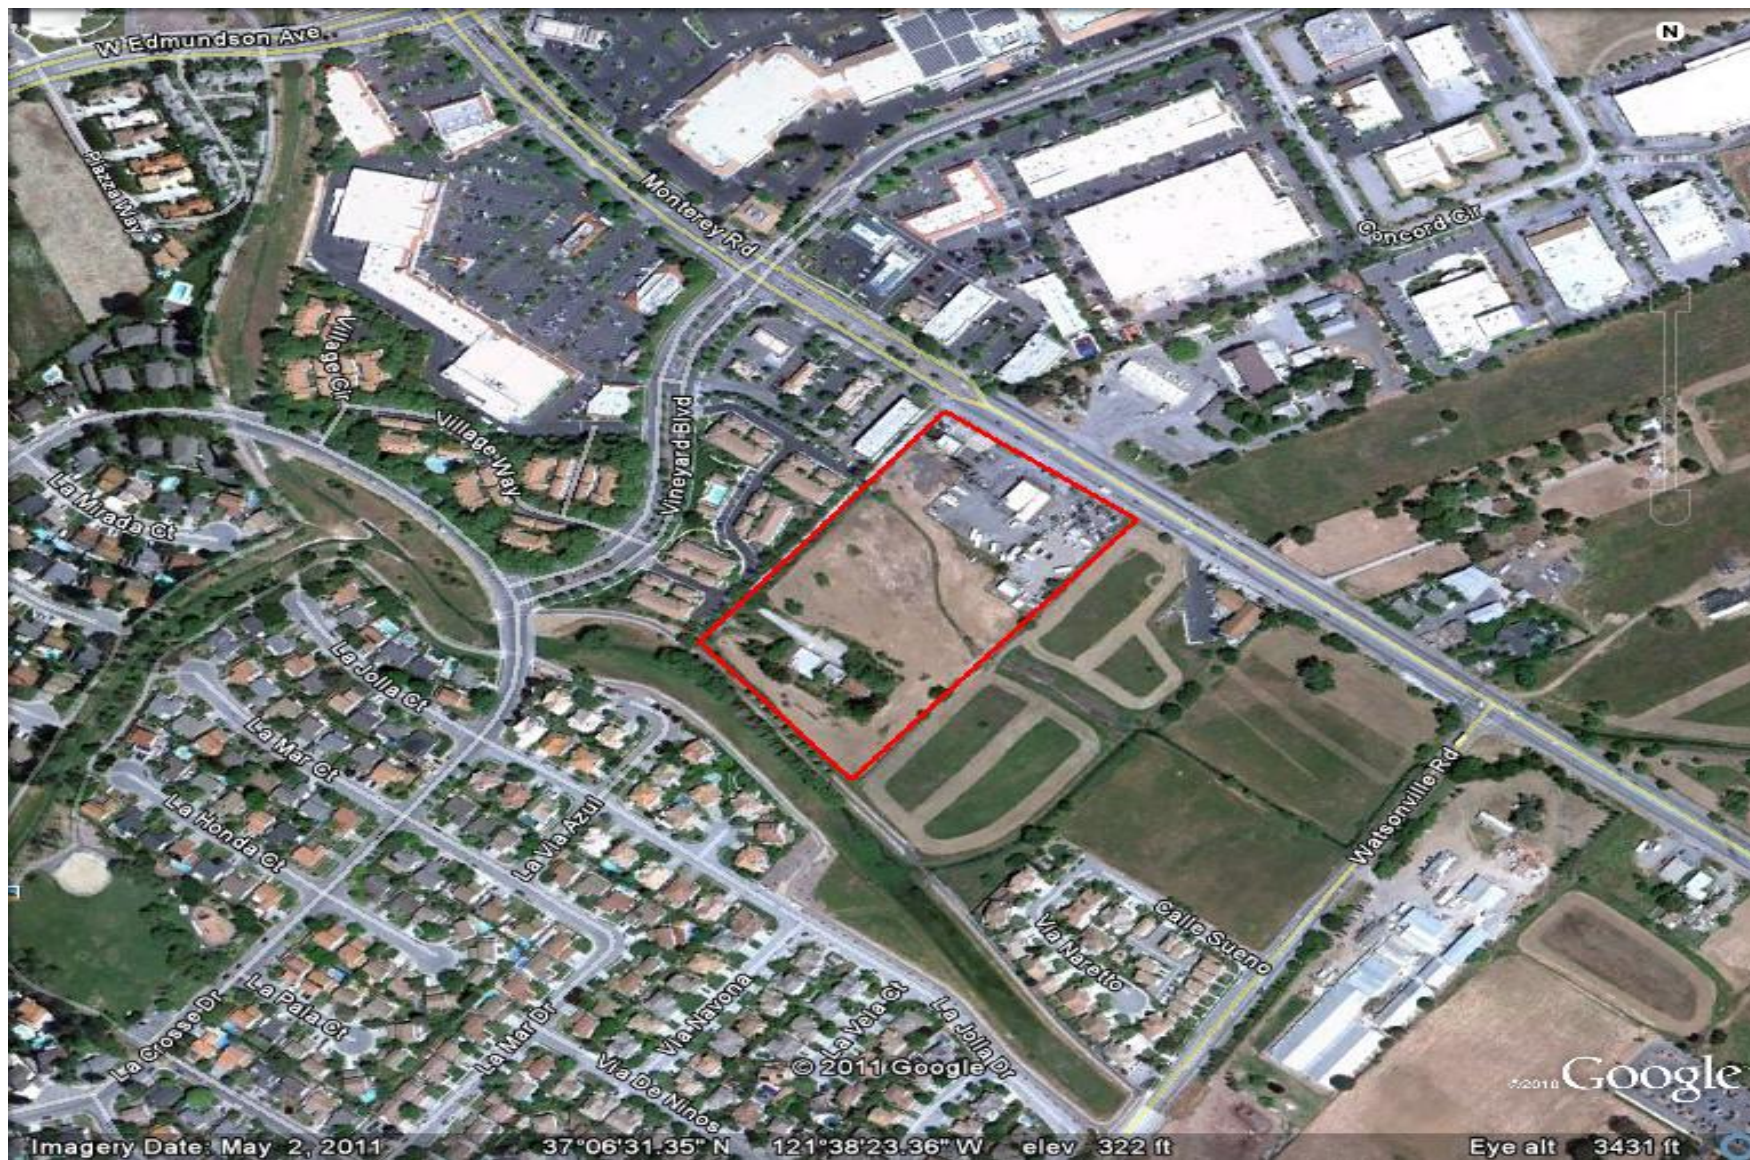
Figure 4
Aerial Photograph

Figure 4
Aerial Photo of the Monterey Dynasty Property
Santa Clara County, California

The Property is located in the city limits of Morgan Hill in Santa Clara County, California (USGS Mount Madonna 7.5 minute quadrangle). Attachment 1, Figure 1 depicts the regional location of the Property in Santa Clara County and Figure 2 identifies the vicinity location. Figure 3 is a topographic map on the USGS 7.5 Quadrangle Map for Mount Madonna. An aerial photograph of the Property is provided in Figure 4.

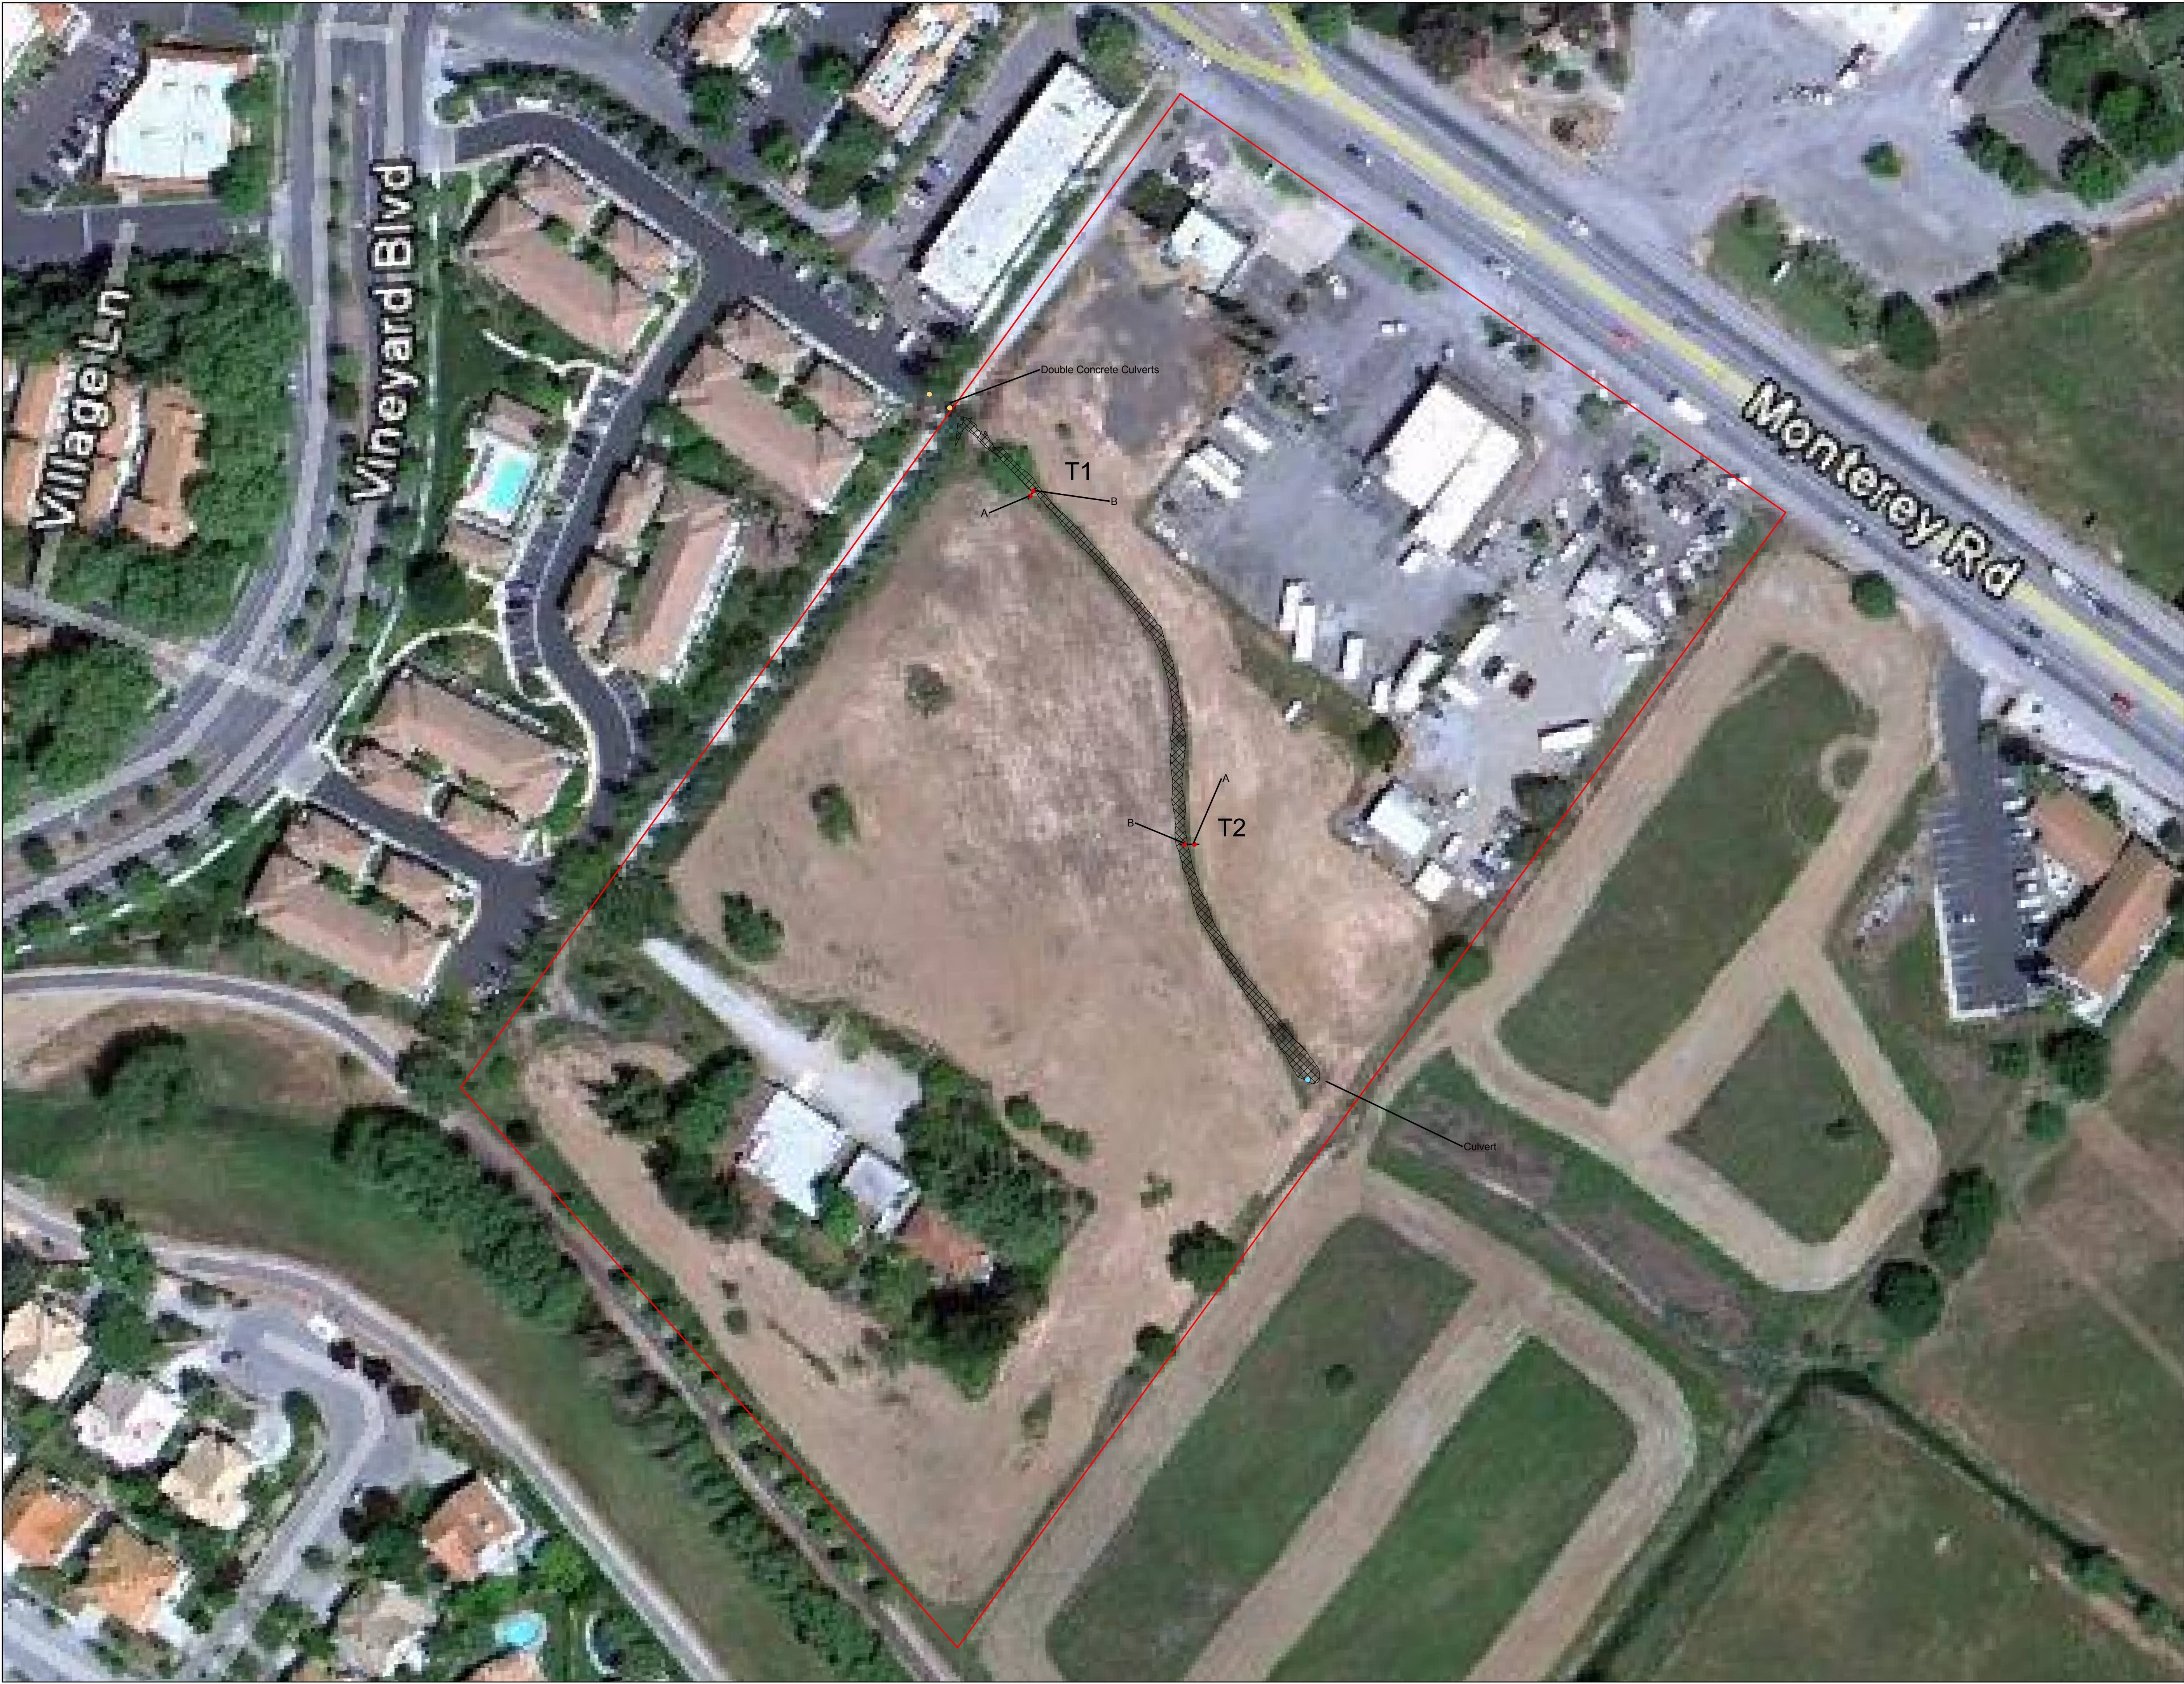
Figure 5
Corps Delineation Map

A total of four soil pits were dug by shovel to a maximum depth of 12 inches at locations representative of various hydrogeomorphic surface conditions along the swale within the Property (Attachment 1, Figure 5).

No jurisdictional “other waters” were found on the Property. The constructed swale is representative of a wetland feature having no defined bed or bank. There is no line of scour and an absence of an ordinary high water mark. The entire swale is vegetation with hydrophytic species and is therefore recognized as a potentially jurisdictional wetland.

Figure 5 Monterey Dynasty Survey Area

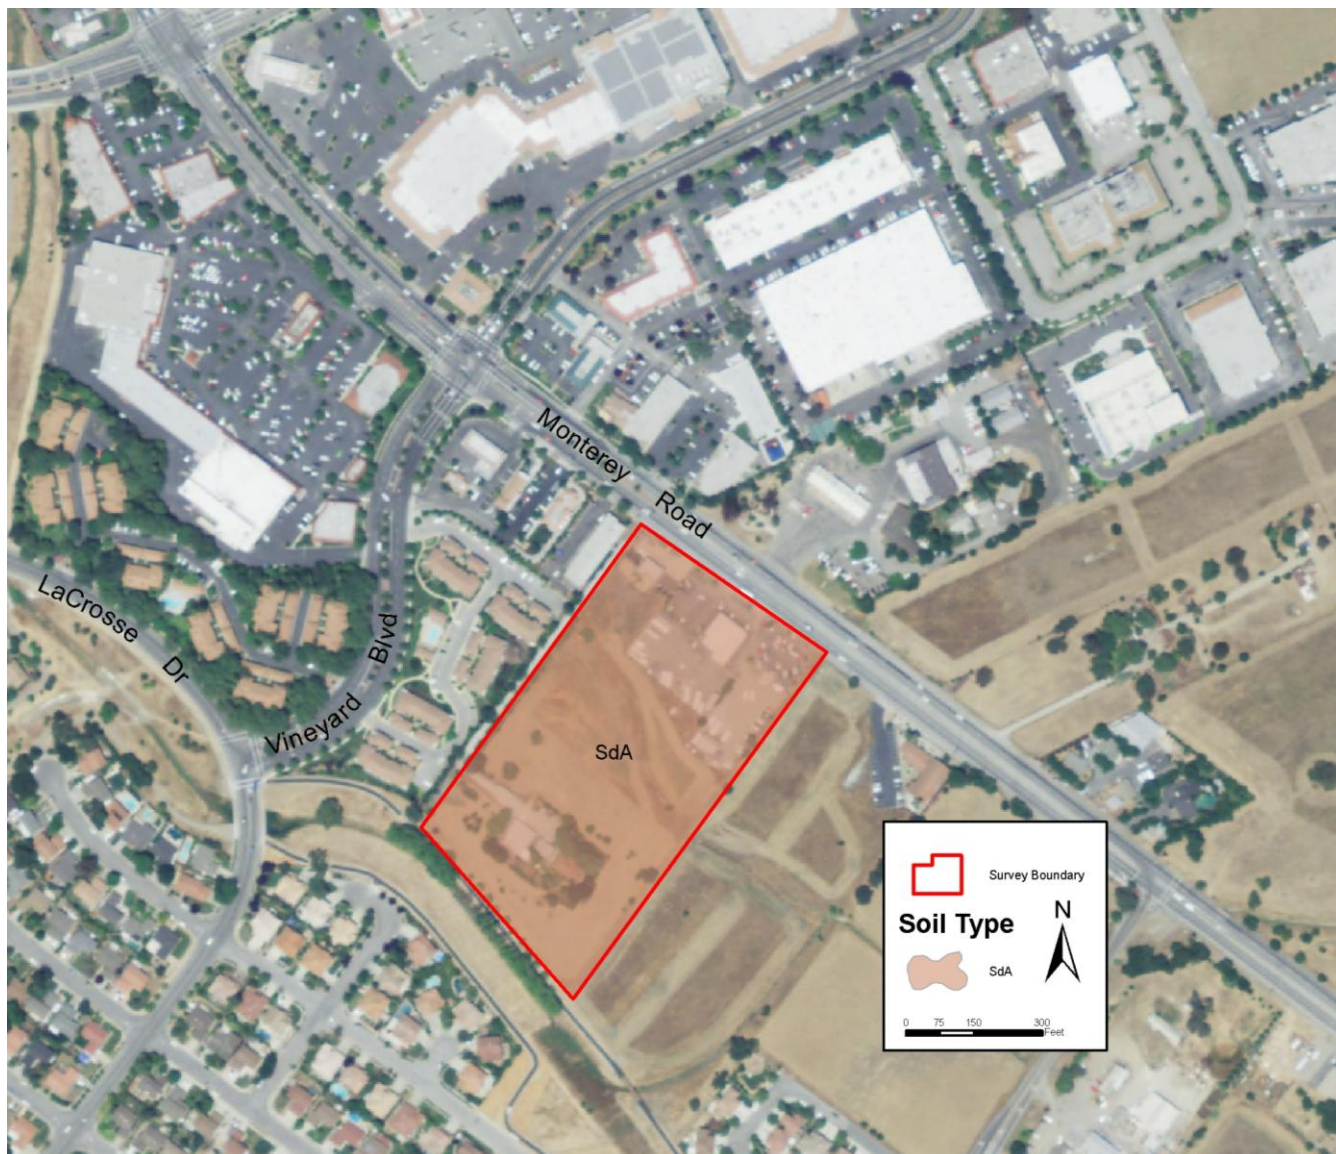
Figure 6
Soils Map

The USDA Natural Resources Conservation Service (formerly the Soil Conservation Service) mapped two soil types within the Property: San Ysidro loam, 0 to 2 percent slopes and Arbuckle gravelly loam, 0 to 2 percent slopes (NRCS 2011). While Arbuckle gravelly loam makes up only a small fraction of the soils on the Property at the northeast corner, the majority of the Property is dominated by San Ysidro loam. Soils were generally friable clay loams throughout the Property. Hydric soils are defined by the National Technical Committee for Hydric Soils (NTCHS) as soils that formed under conditions of saturation, flooding, or ponding long enough during the growing season to develop anoxic conditions in the upper part. Neither soil found on the Property is considered hydric.

A detailed map of these soils for the Property can be found in Attachment 1, Figure 6. A detailed description of both soil types can be found in Attachment 5. The numbers in parentheses next to the soil types represent the percentage amount on the Property. The soils mapped included the following types:

Map Unit Symbol	Percentage Within Property	Map Unit Name
SdA	100 %	San Ysidro loam, 0 – 2% slopes

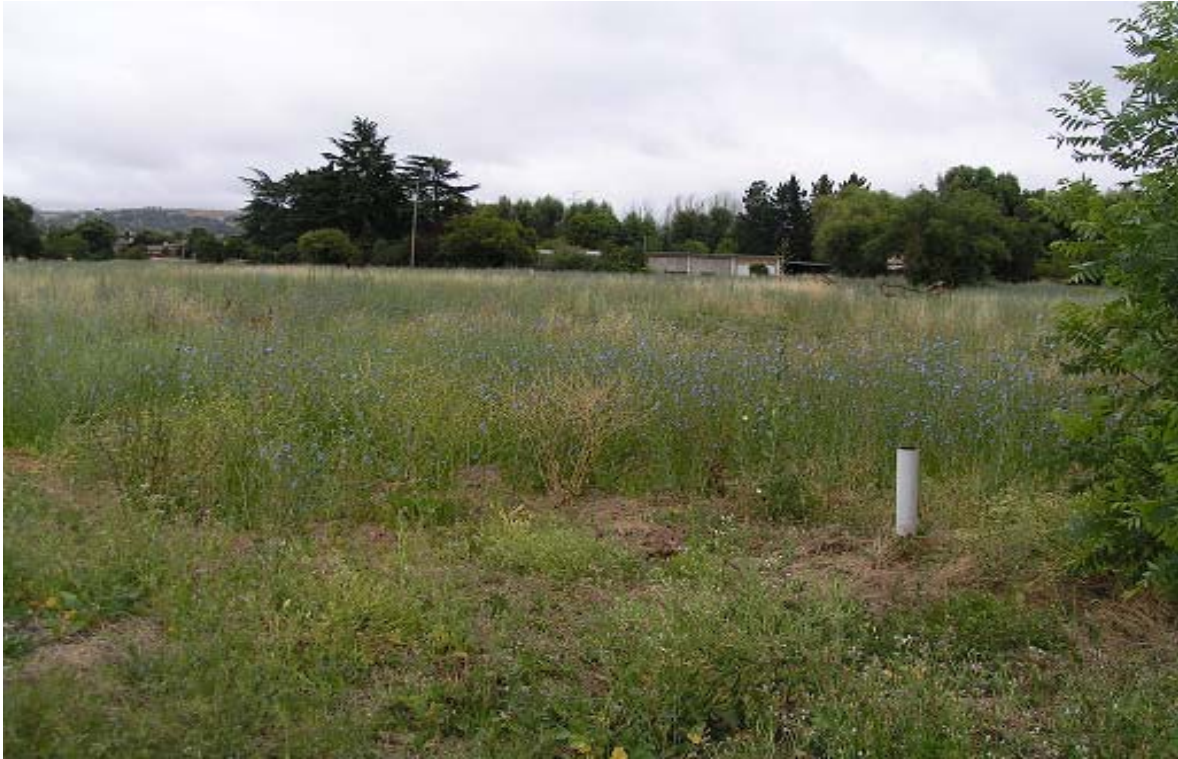
Ruderal habitats consist of largely naturalized vegetative assemblages of annual and biennial grasses and broad-leaved plants. With the exception of the area around the former residence, the majority of the Property has been disced for weed abatement, resulting in this habitat type. Dominant and co-dominant plants observed included chicory (*Cichorium intybus*-UPL), yellow star-thistle (*Centaurea solstitialis*-UPL), black mustard (*Brassica nigra*-UPL), wild radish (*Raphanus sativus*-UPL), prickly lettuce (*Lactuca serriola*-FAC), bitter lettuce (*Lactuca virosa*-UPL), and wild oat (*Avena fatua*-UPL). Other common species observed included English plantain (*Plantago lanceolata*-FAC), hoary cress (*Cardaria draba*-UPL), red-stem filaree (*Erodium cicutarium*-UPL), and annual fireweed (*Epilobium brachycarpum*-UPL).

Photograph 1. Representative photograph of Property, facing southwest towards abandoned residence. Note prevalence of chicory, wild radish, and other species associated with ruderal habitats.

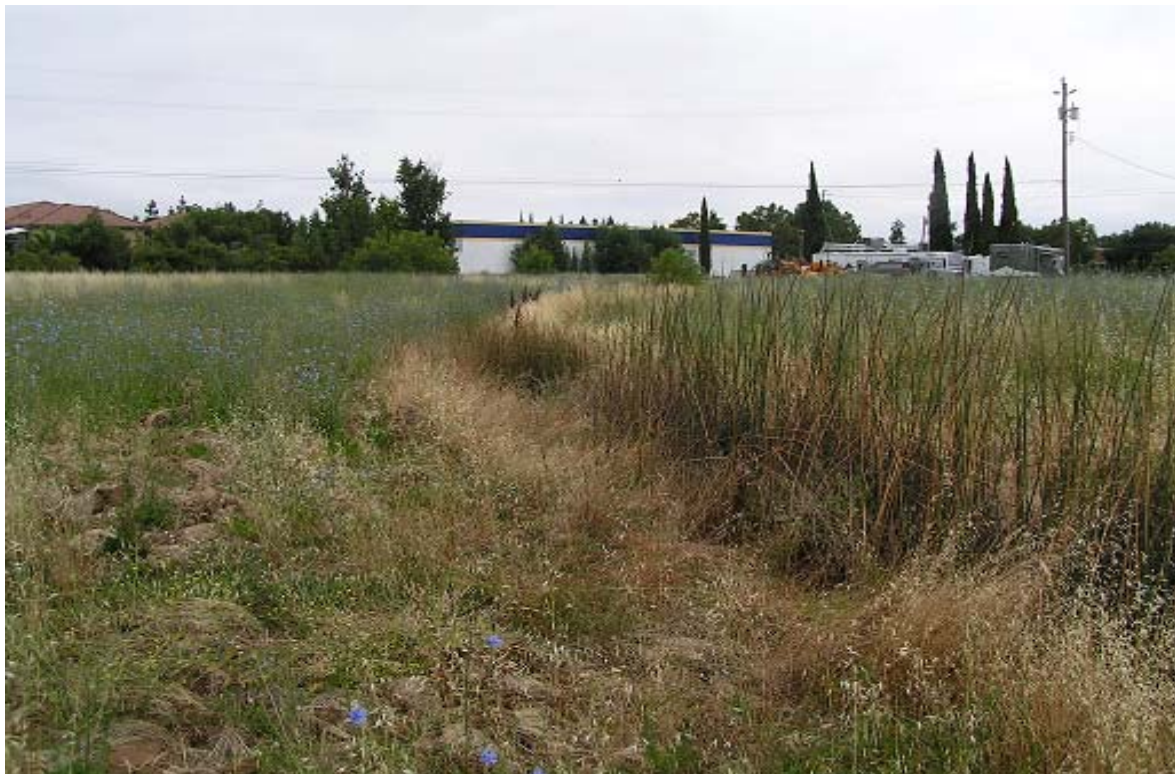
While the majority of this low-gradient feature contains a mix of upland and hydrophytic species, hydrophytes generally provide a greater percent cover. Dominant and co-dominant species observed included chicory, wild radish, English plantain, field bindweed (*Convolvulus arvensis*-UPL), perennial ryegrass (*Festuca* [*Lolium multiflorum*] *perennis*-FAC), curly dock (*Rumex crispus*-FACW), and cocklebur (*Xanthium strumarium*-FAC).

Some portions of the grassy swale were slightly deeper, allowing for a longer hydroperiod to occur during the rainy season, resulting in the establishment of some isolated stands of obligate (OBL) and facultative wetland (FACW) hydrophytes including California tule (*Schoenoplectus californicus*), Baltic rush (*Juncus balticus*), and tall flatsedge (*Cyperus eragrostis*).

Photograph 2. Photograph showing the low-gradient swale that bisects the Property along a northwest-to-southeast axis. Slightly deeper portions support small stands of obligate hydrophytes, such as California tule.
